HEADQUARTERS AIR FORCE SPECIAL WEAPONS CENTER

Technical Note

THE FEASIBILITY OF USING REMOTELY CONTROLLED
VEHICLES TO DECONTAMINATE LARGE PAVED AREAS

AFSWC-TN-60-25

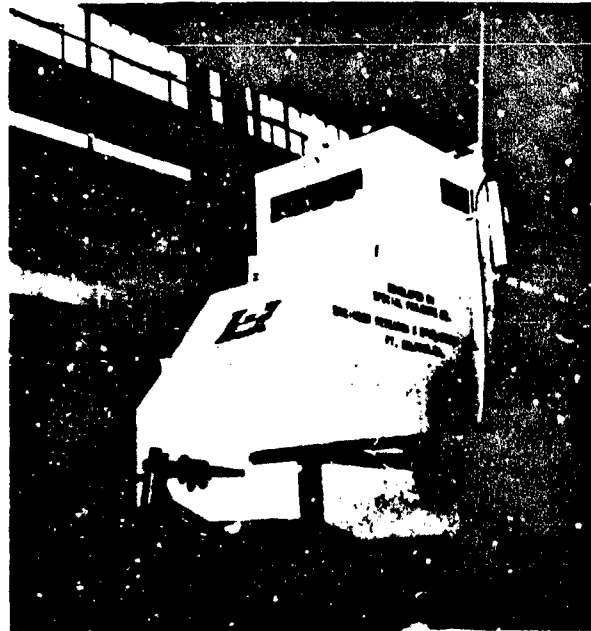
Figure 1. Shielded cab on ERDL tractor.
US Army Photo

The use of 1-inch lead in the floor area and the sides of the cab and 1/2-inch lead for the cab top would allow the weights of these various cabs to fall within the cab recommendations. It would not be desirable to mount the cabs directly to the deck structure, but supports could be built on the tractor main frame and bevel gear cases to support the added weight. Some relocation work, such as moving controls to bring them into the cab area through pivoting shafts, would be required. This would eliminate the necessity for providing slotted clearance holes, and thus prevent radiation leakage. Some of the instruments would require relocation for operator.

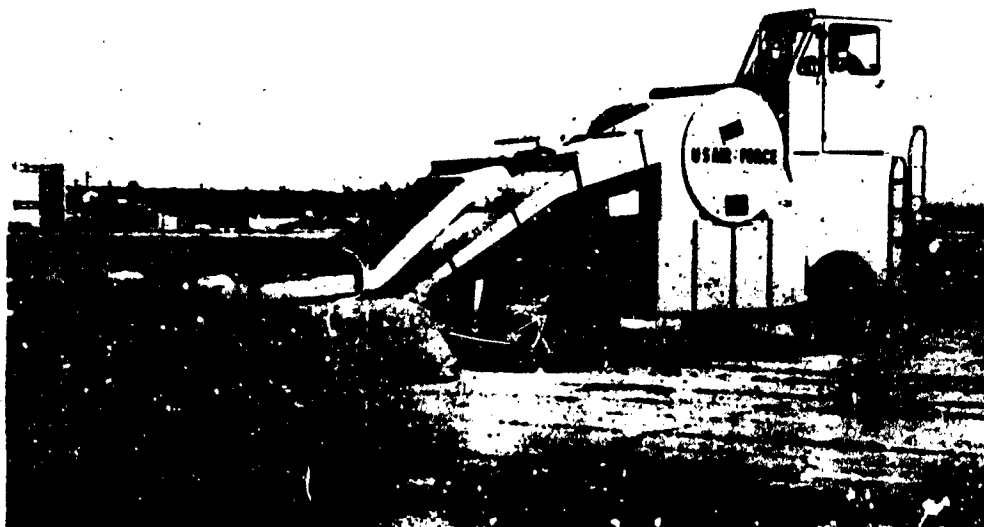
Figure 3. Coleman runway vacuum sweeper.

The requirements from ARDC closely paralleled the specifications of the Coleman Runway Vacuum Sweeper developed by the Coleman Engineering Company, Inc. of Los Angeles, California (see figure 3). The feasibility of shielding the operator's cab had already been studied and found impractical. Depending upon material used and space required for the operator, an added weight of 6,000 to 20,000 pounds would be required. This might be used in some instances on heavy equipment, but would seriously impair the operation of a relatively light vehicle.

Investigation of the Coleman sweeper indicated that extensive modification to the unit would be necessary to make it suitable for decontamination purposes. The US Naval Civil Engineering and Research Evaluation Laboratory at Port Hueneme, California, had initiated a study contract with the Coleman Engineering Company to determine the feasibility of adapting the Coleman-designed airfield vacuum cleaner for use in effectively decontaminating paved areas.

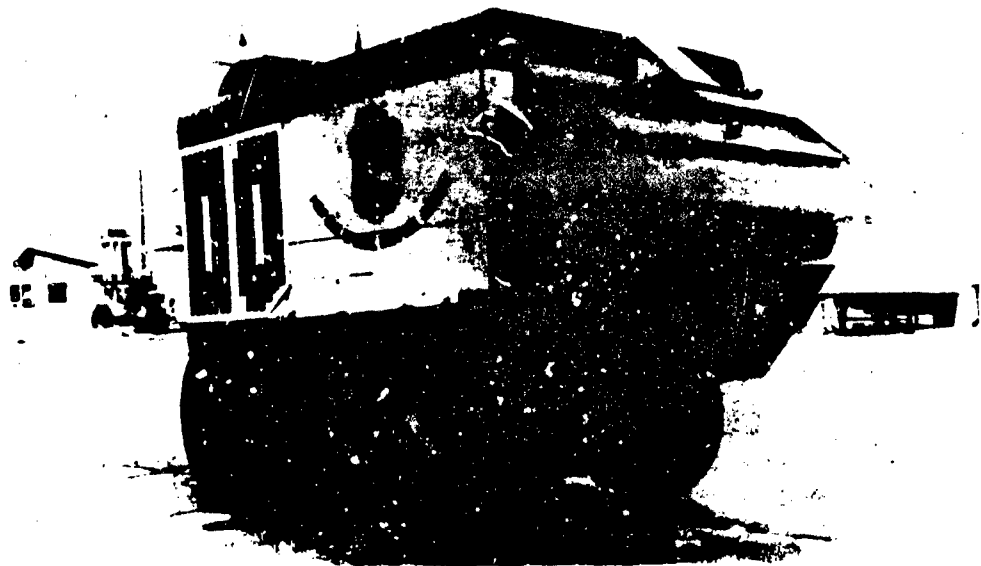
Figure 4. Tennant model 100 vacuum sweeper.
G. H. Tennant Photo

Decontamination efficiency of the Model 100, even though exceptionally good, can be improved by addition of greater vacuum and air agitation.

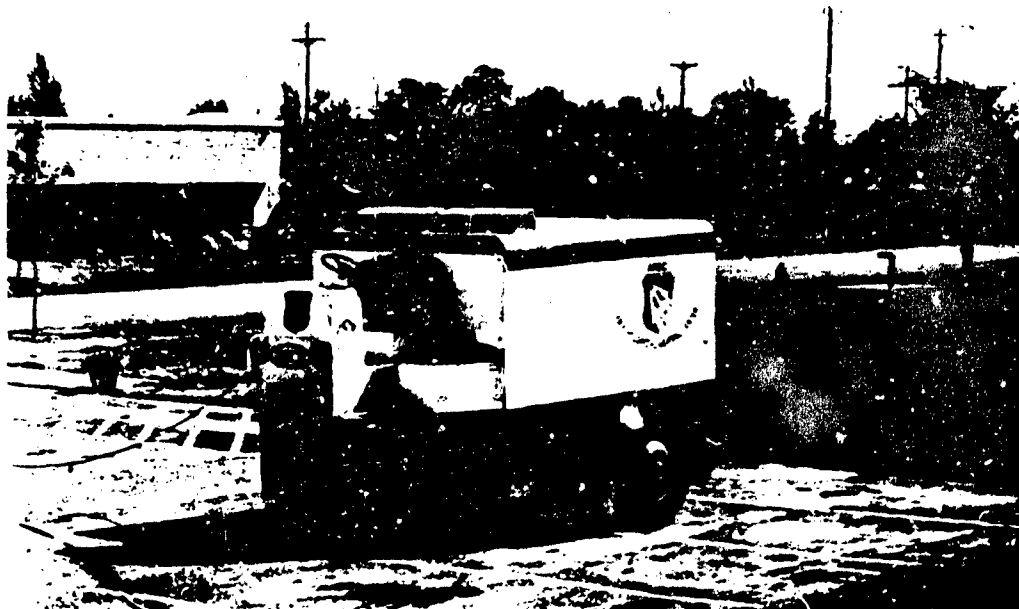
Figure 5. ARDC-Tennant model 100DS vacuum sweeper.
G. H. Tennant Photo

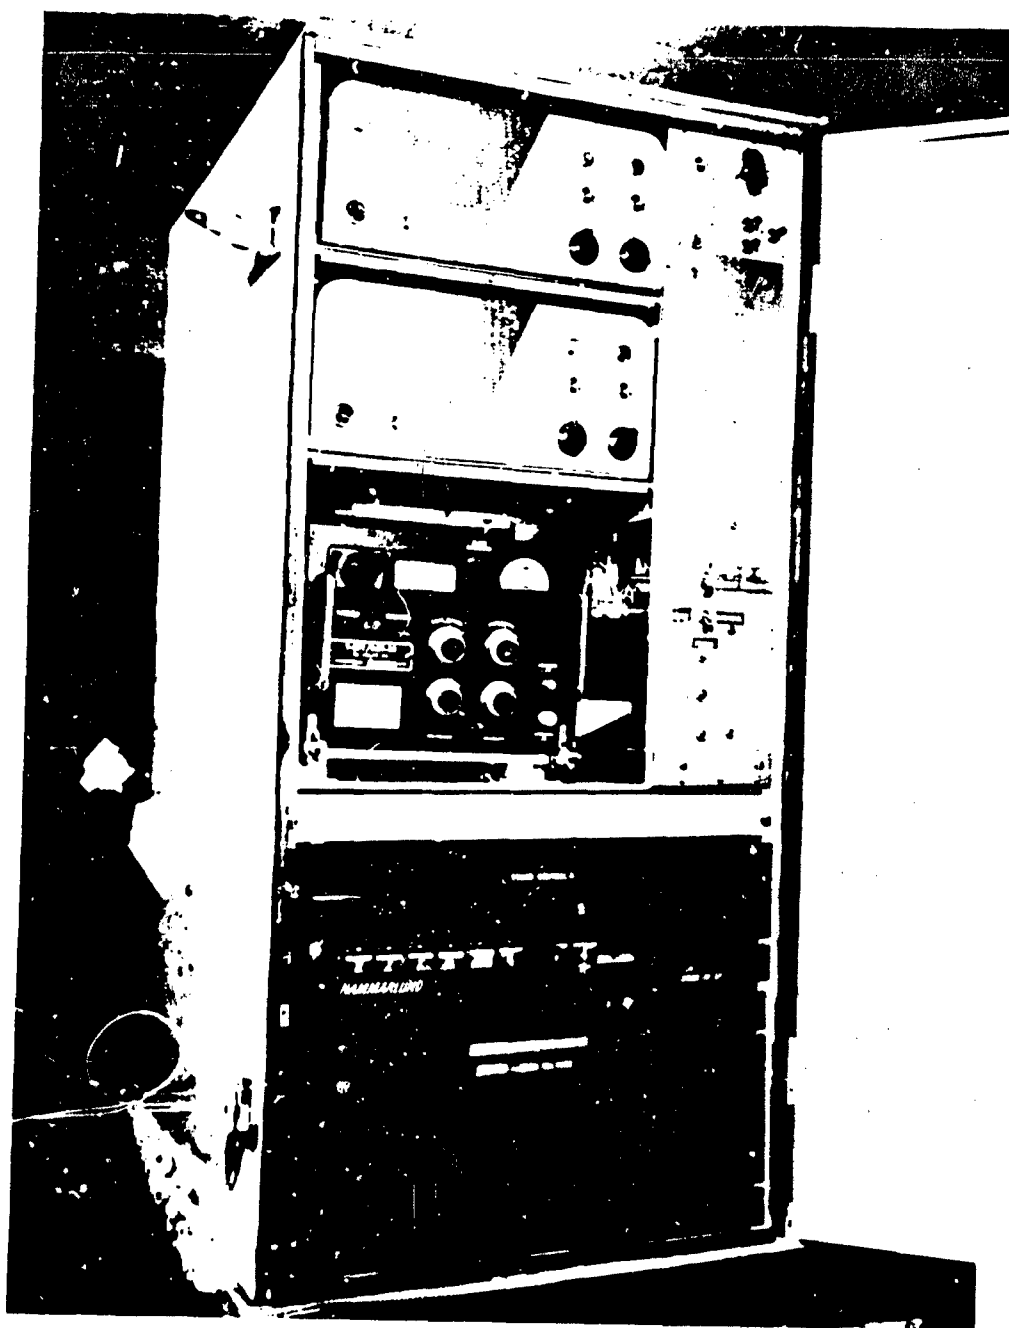
Figure 1. Electronic equipment mounted on vehicle.
